RETRO-COAT HELPS SPEED REAL ESTATE TRANSACTION

**CASE STUDY:
Vapor Intrusion Effectively
Mitigated at Former Landfill Site**

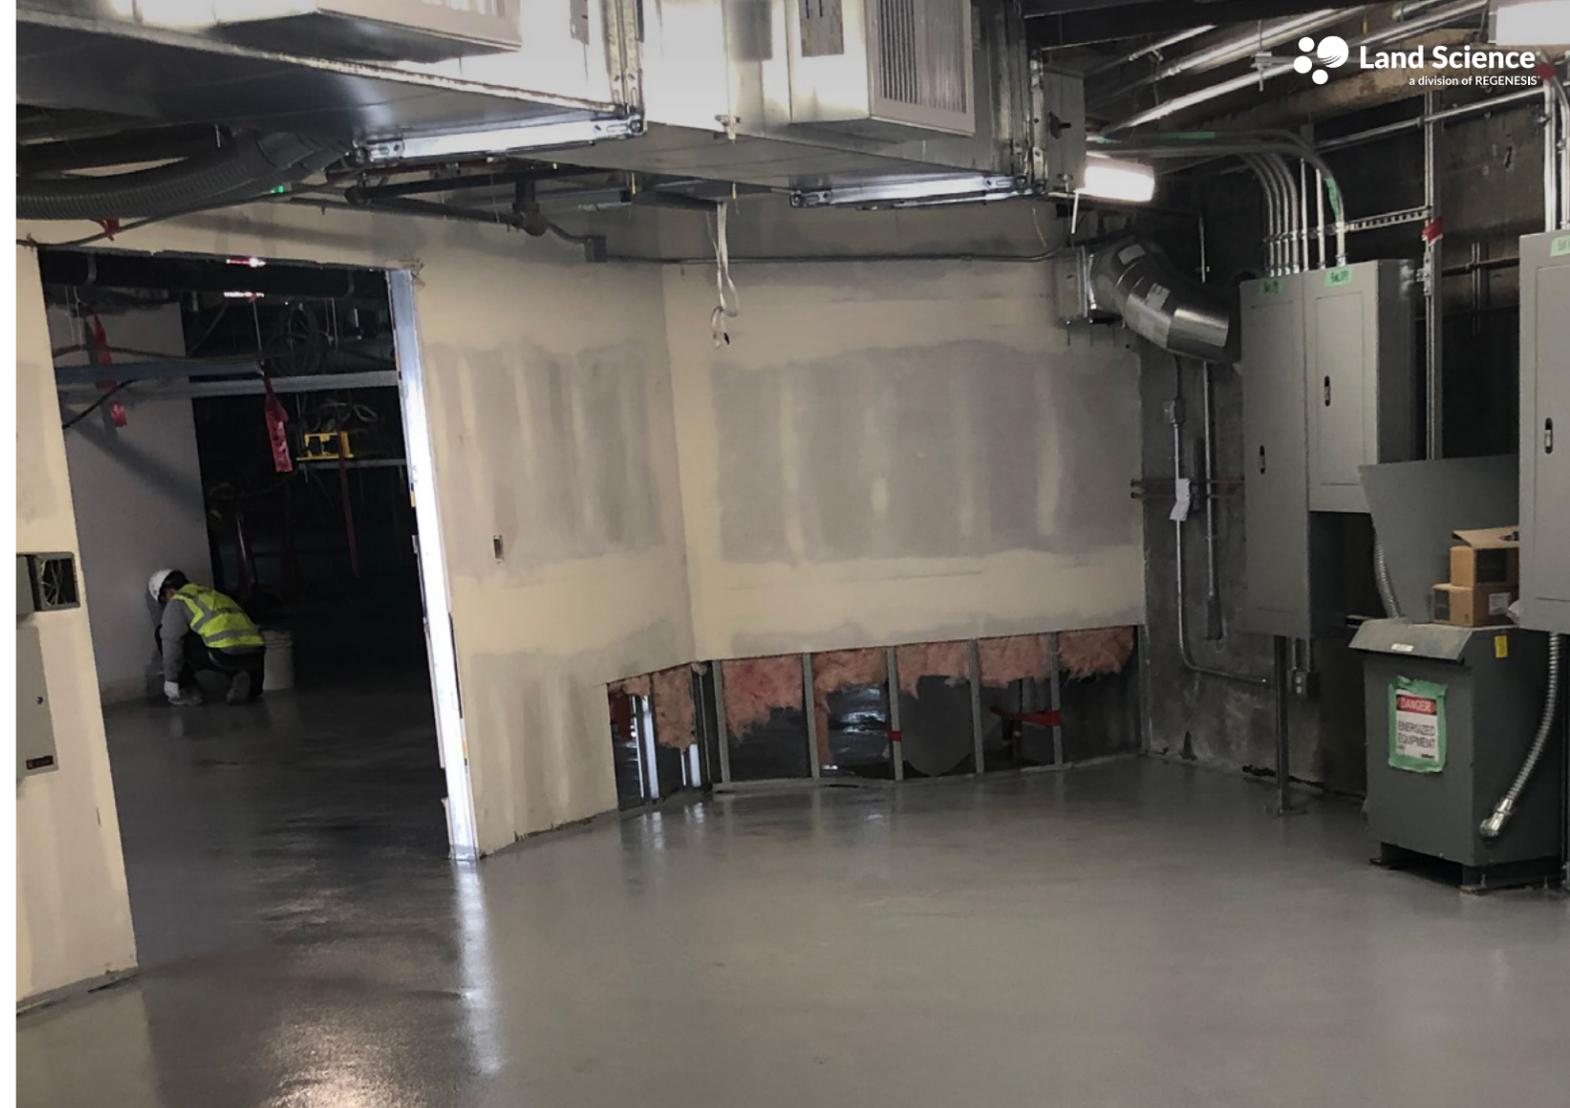
First, the concrete was cleaned and abraded. Then, Retro-Coat caulk was applied to seal any areas of possible penetration.

Once the area was sealed and prepared, the Retro-Coat Primer was applied at 6 mil.

After the primer dried, Retro-Coat was applied in two 10 mil coats using a squeegee and back-roll method.

Once Retro-Coat dried tack-free, the self-priming sealer was applied. This was applied at a 160 square feet/gallon coat. Due to the fast curing time, this project was completed quickly, allowing the tenants to move in on a prompt timeline.
