VAPOR BARRIER SPEEDS REDEVELOPMENT OF FORMER TEXTILE MILL

CASE STUDY:

Tax Credits Pave the Way for Co-Work Space Bringing Technology Jobs

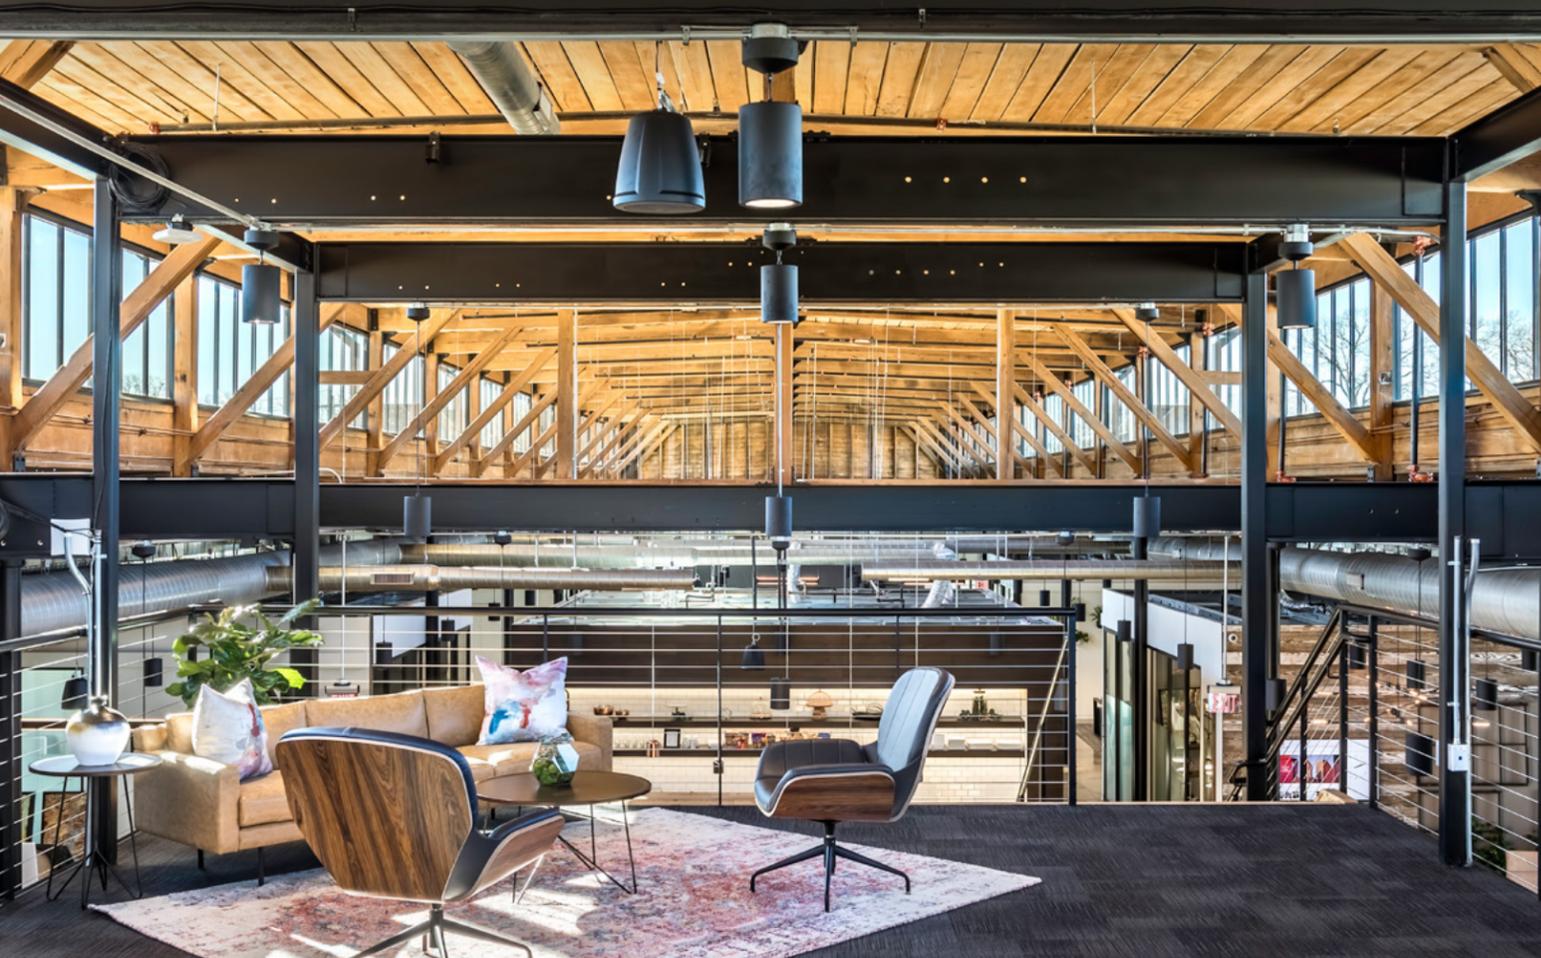
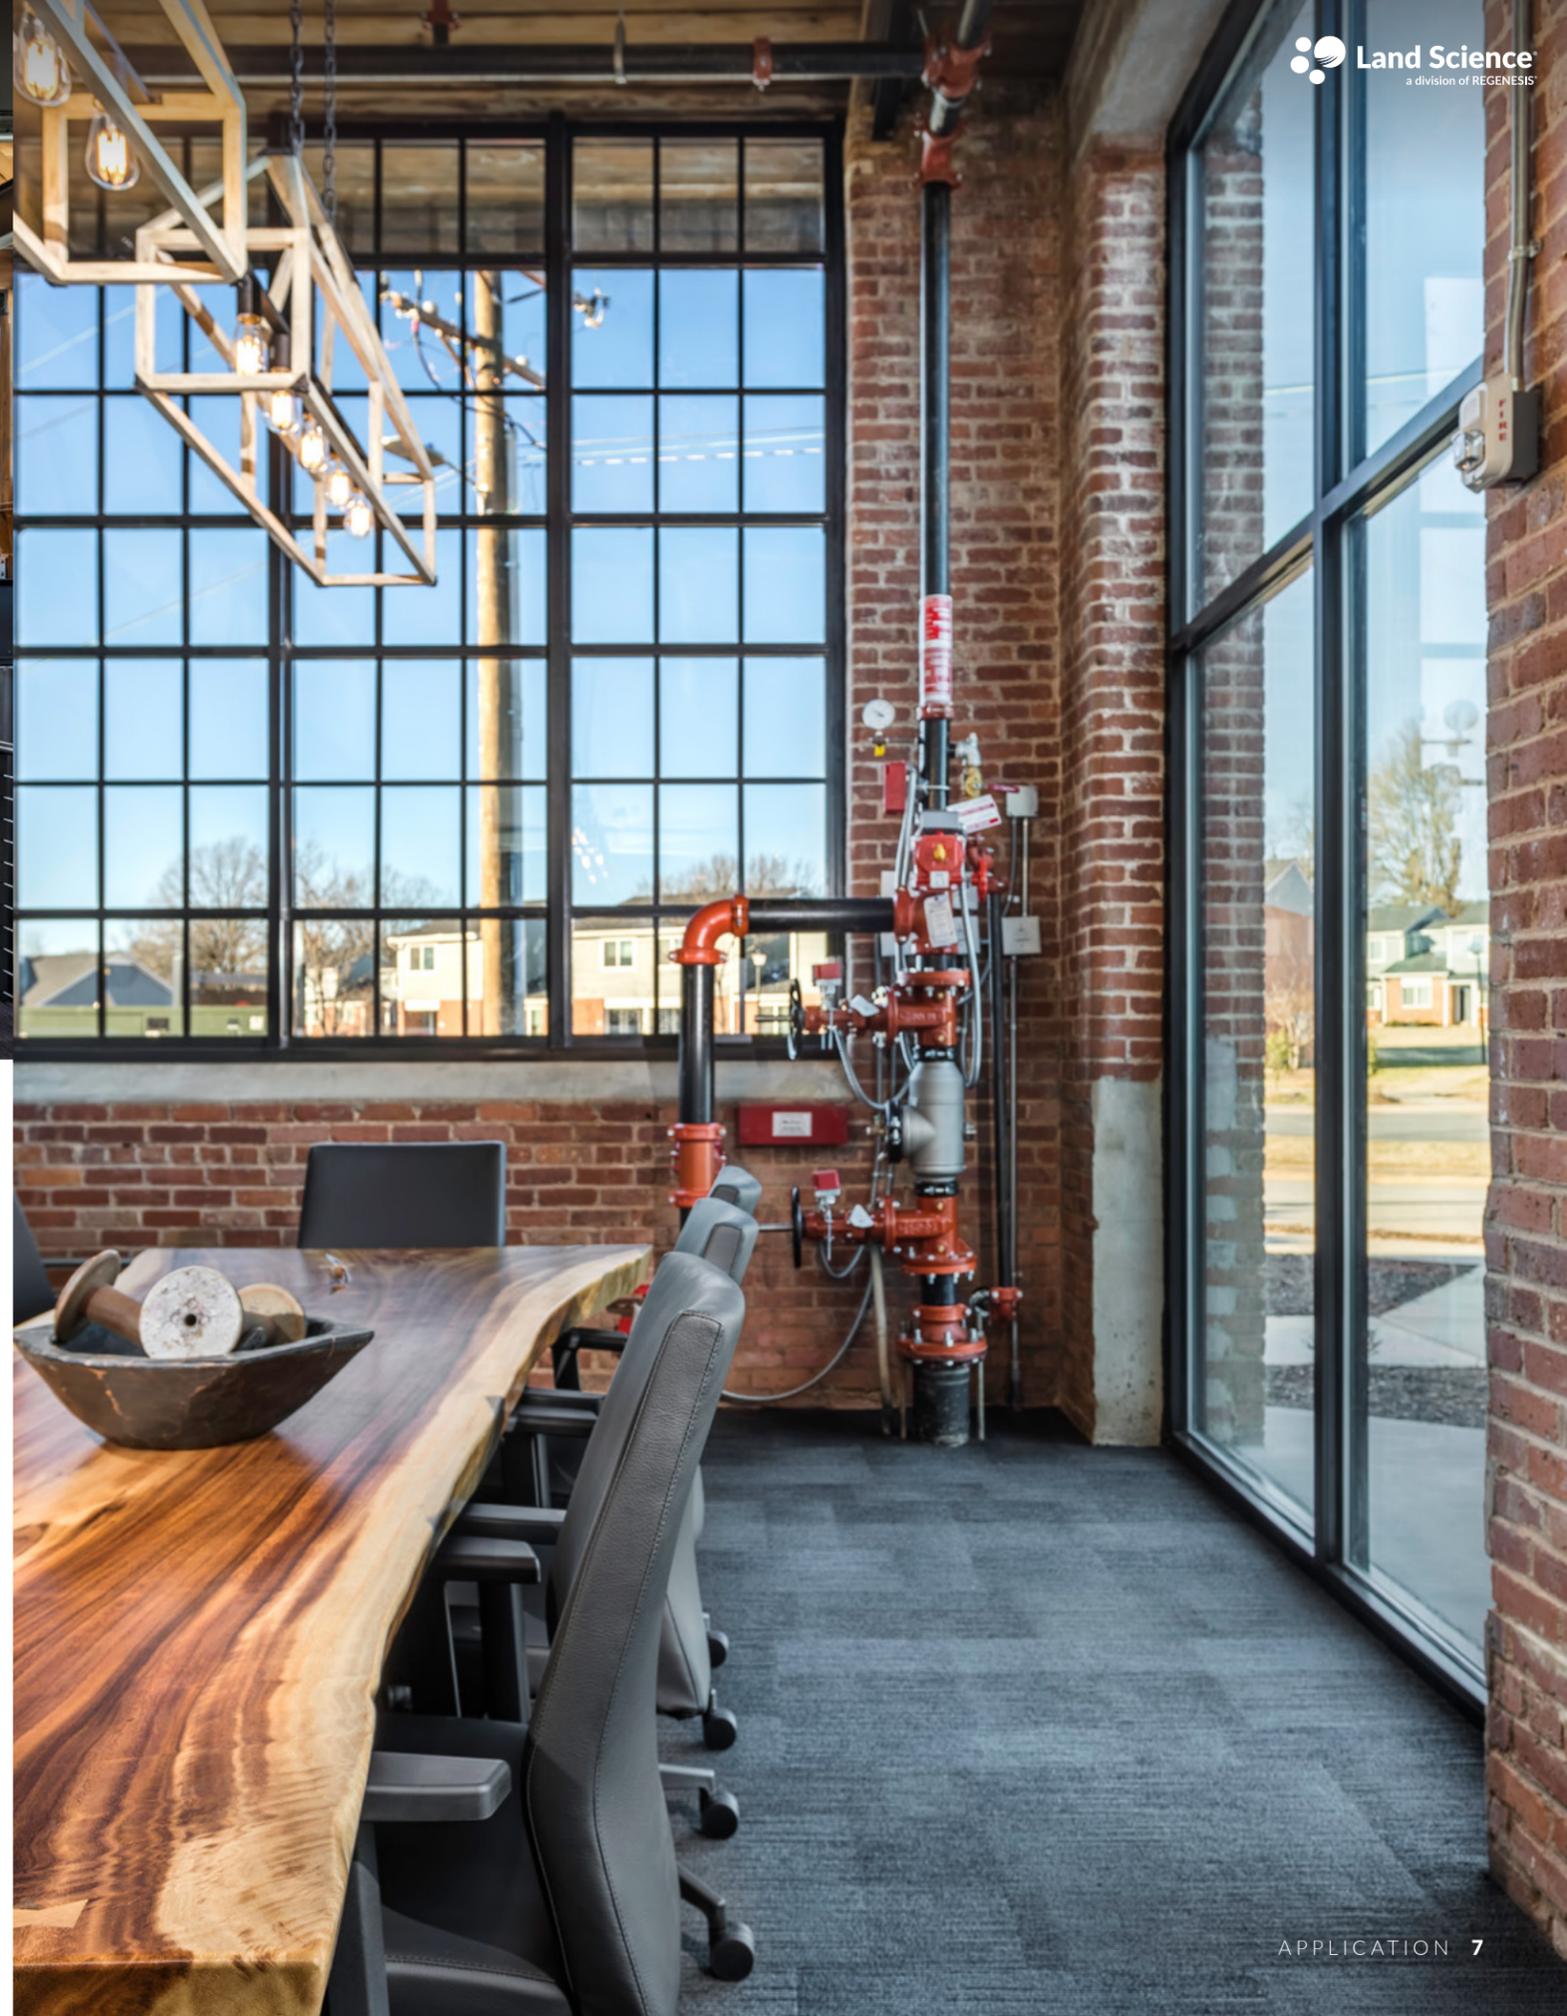
Prior to remediation, several outbuildings were torn down because they were structurally unsound or had deteriorated to the point of collapse. The main building on the site was preserved and renovated. The flooring of the main building was made partially of concrete and partially of wood laid directly on the soil. Because of the floor's poor conditions and variability, EnviroSouth advised the developers to remove the floor slab completely. After removing the slab, the old flooring was not considered to be a risk and was disposed of as normal construction material.

Geo-Seal was installed to mitigate the harmful vapor intrusion from the 24,500 square foot building. The new floor slab features a polished grind and sealed concrete without any of the risk that the older, highly-variable flooring had.

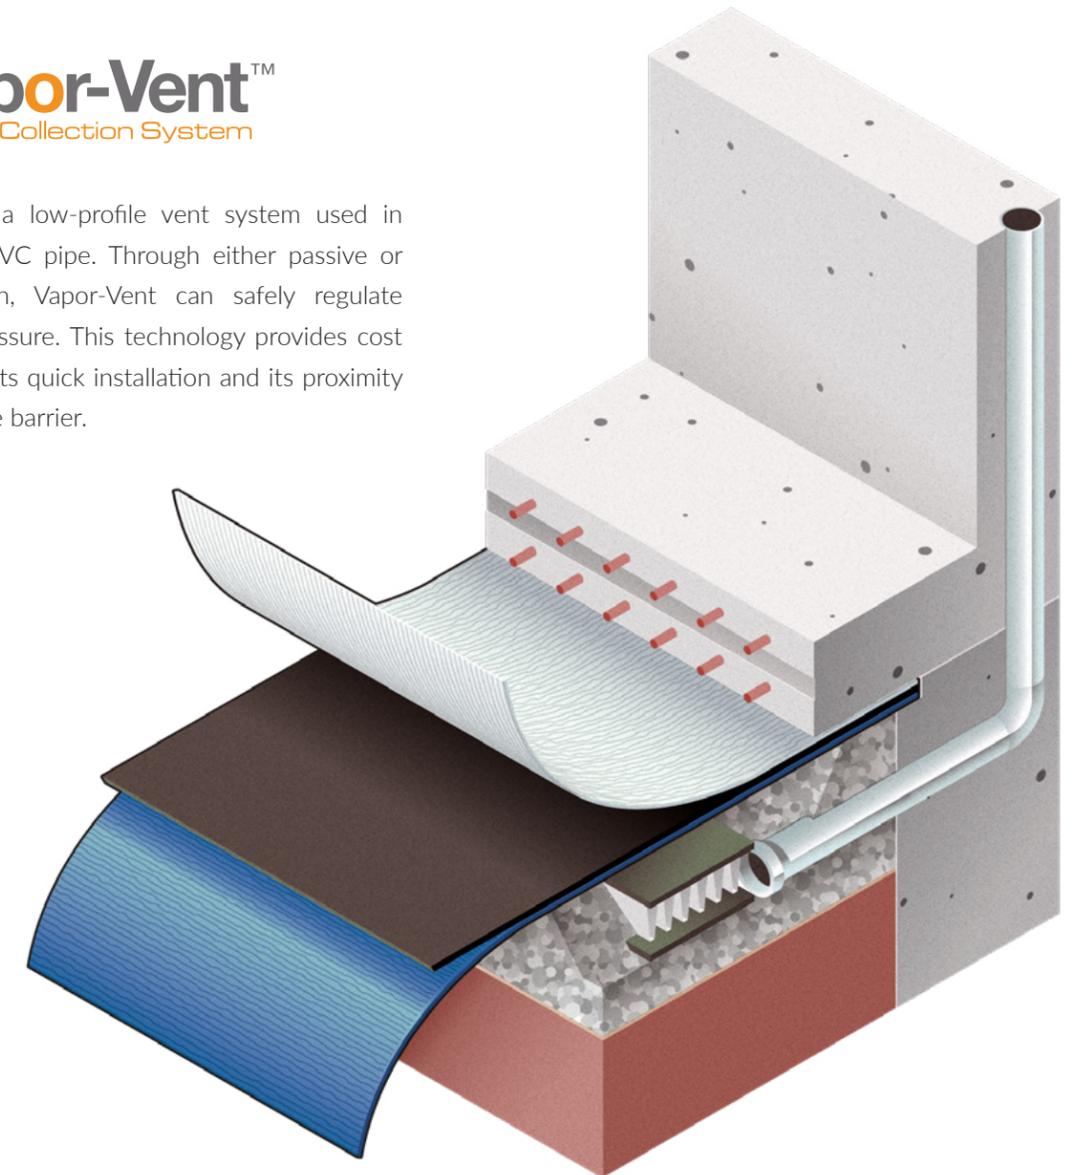
Geo-Seal® is a gas vapor management technology designed to eliminate vapor intrusion on Brownfields or any type of environmentally-impaired site. Geo-Seal is a chemically-resistant material placed between the foundation of the building and the soil pad to eliminate vapor intrusion pathways and stop contaminant vapors from permeating through the slab. By deploying Geo-Seal, developers can ensure a healthy indoor environment while reducing the cost of site remediation and expediting site construction.

Vapor-Vent® is a low-profile vent system used in lieu of slotted PVC pipe. Through either passive or active ventilation, Vapor-Vent can safely regulate underground pressure. This technology provides cost savings through its quick installation and its proximity of the vent to the barrier.
