CLOSURE ACHIEVED WITH COST-EFFECTIVE VAPOR INTRUSION SOLUTION

**CASE STUDY:
Retro-Coat Applied To
Former Jazz Club Ensures
Protection From Vapor Intrusion**

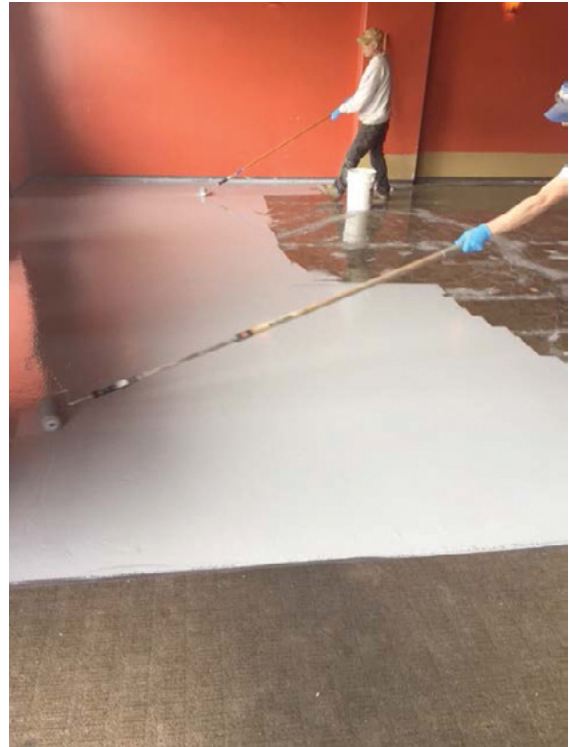
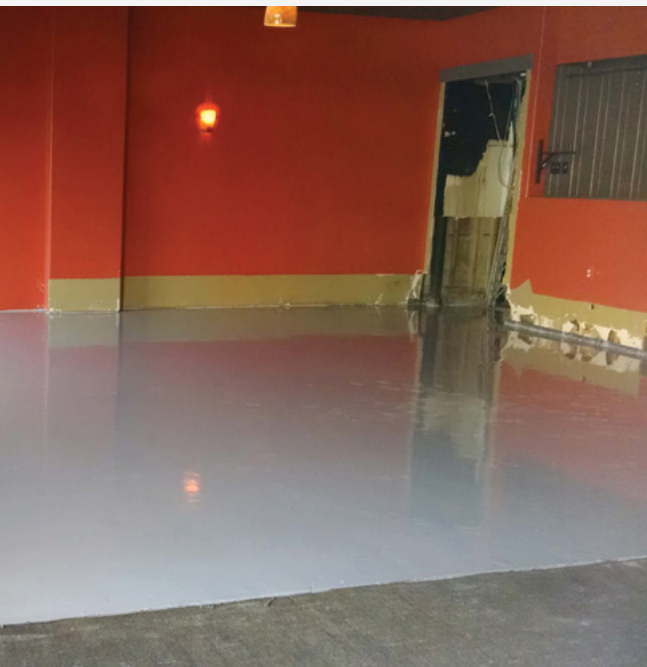
The concrete was first prepped by diamond grinding and shot blasting the surface to create a profile within the existing floor for maximum bonding of the Retro-Coat barrier system.

All cracks, holes, and expansion joints were filled with a Retro-Coat caulk. A 6-mil Retro-Coat Primer was then applied across the entire concrete floor to prepare for the Retro-Coat barrier.

Following the curing of the Retro-Coat Primer, Retro-Coat was applied using squeegees and rollers applying two 10-mil applications, for a cured thickness of 20-mils.

The safe, effective and efficient installation of the Retro-Coat Vapor Mitigation System was completed within three days.
